QUEENSLAND WATER MODELLING NETWORK

Landscape restoration and redesign

Review of river reach case studies and Dynamic SedNet model parameterisation

Report prepared by
Alluvium Consulting
For the Queensland Water
Modelling Network

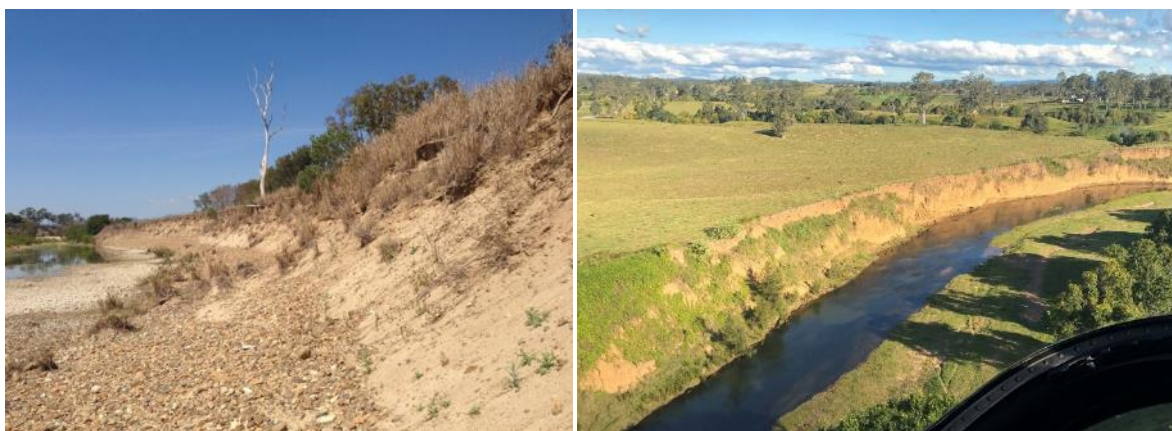
Figure 1: *Stream bank erosion along the O'Connell River (left) and Mary River (right)*

Stream bank erosion represents a major source of sediment to the GBR lagoon. Erosion is a natural and essential process in alluvial systems; however human activities such as land clearing, removal of riparian vegetation or grazing pressure that limits reestablishment of vegetation can result in accelerated rates of stream erosion resulting in damaging channel change. These erosion processes provide a pathway for sediments and nutrients, such as nitrogen and phosphorous, to enter waterways. Land use changes within the GBR catchments have resulted in significant increases in sediment and nutrient loads to the GBR lagoon. As a result, stream bank erosion has been identified as a major sediment and particulate nutrient delivery process impacting on the GBR (Figure 1, Figure 2 and Figure 3).

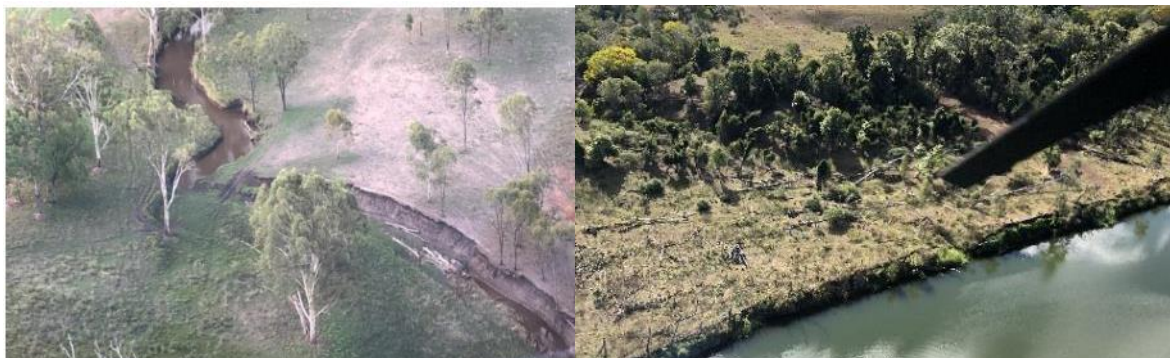
Figure 2: Stream bank erosion along the Mimosa Creek (Dawson River catchment) (left) and Burnett River (right)

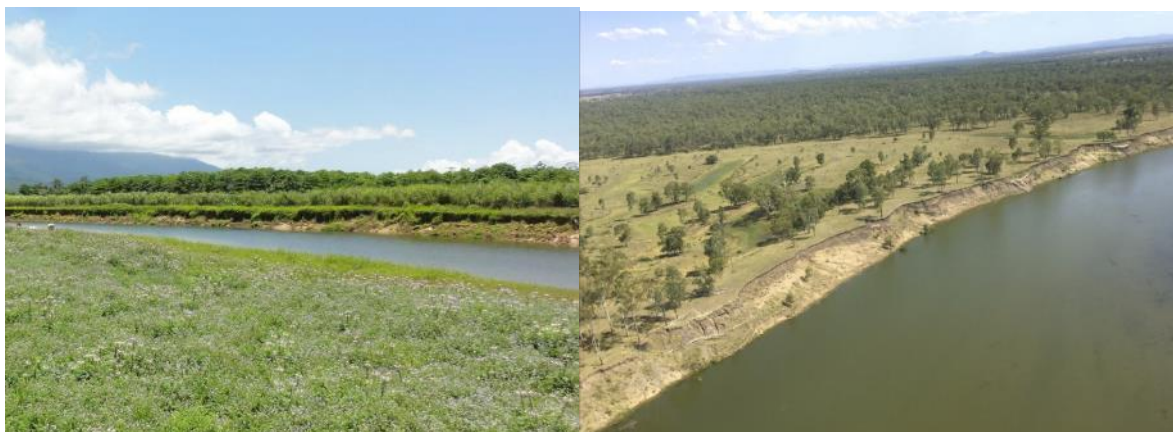
Figure 3: Stream bank erosion along the Russell River (left) and Fitzroy River (right)

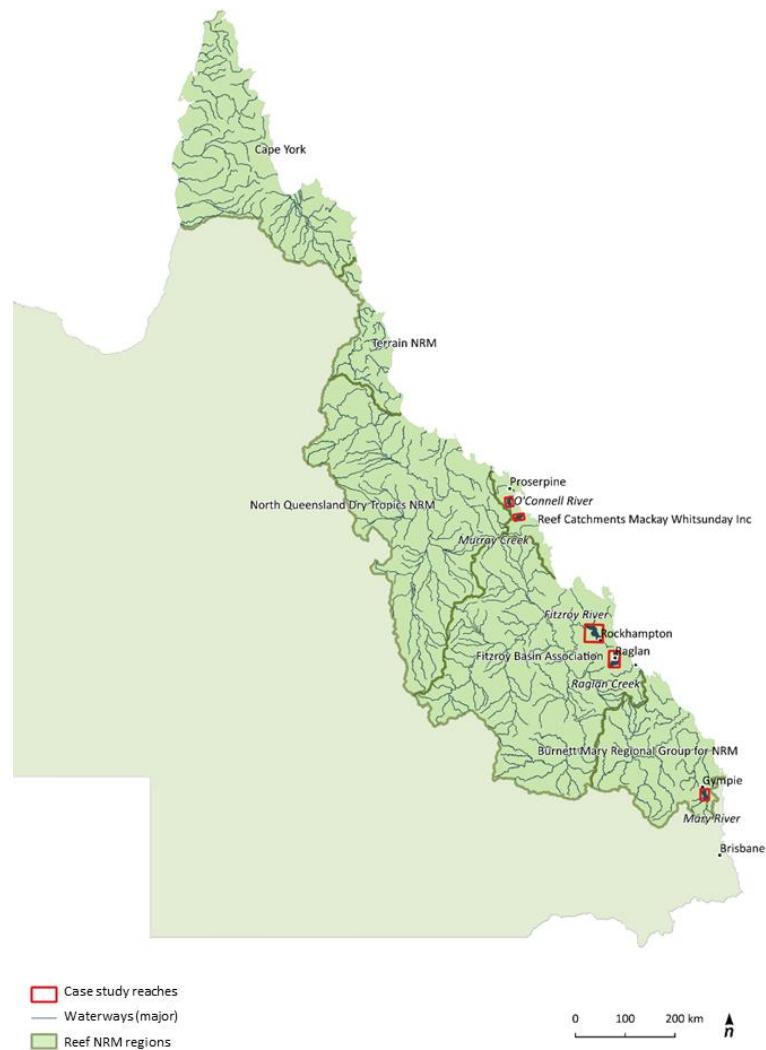
Figure 4: *The location of the five case study areas*

The five case study areas are located within the Mary River catchment, Fitzroy River catchment and Mackay-Whitsundays region. The case studies are shown in Figure 4 and summarised in Table 1. Each of the five case study areas are discussed below.

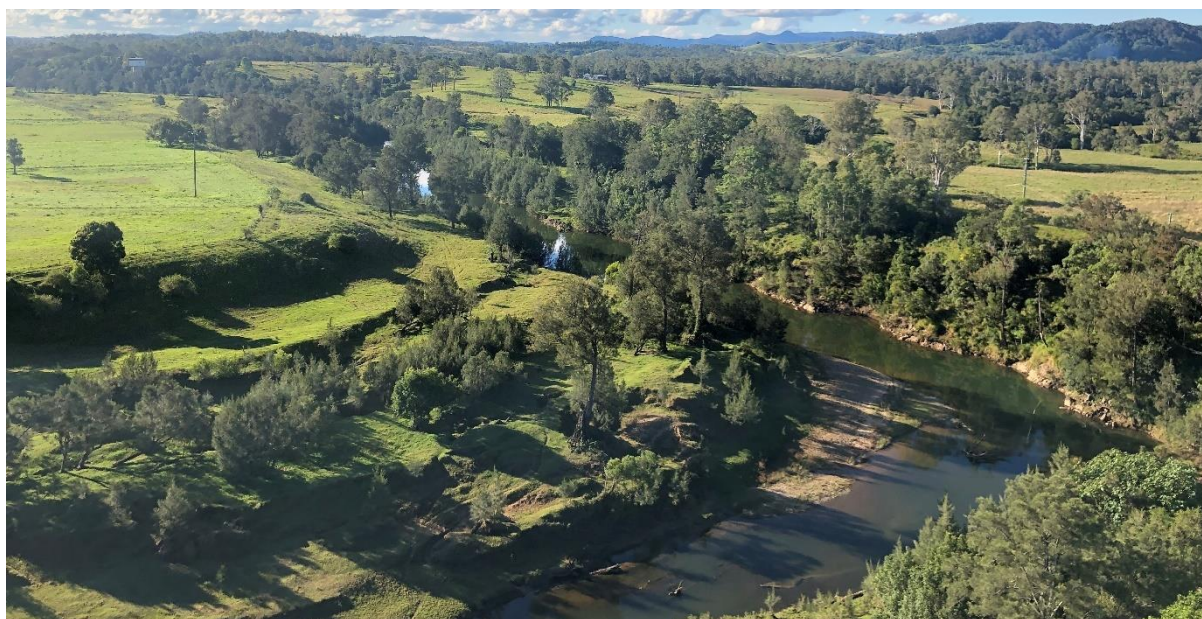
Figure 9: *View south along Mary River showing the higher terrace and inset floodplain unit*

Variations in the degree of channel entrenchment and geomorphic units can be seen in the three typical section shown in Figure 8. The main geomorphic units are also visible in Figure 9.

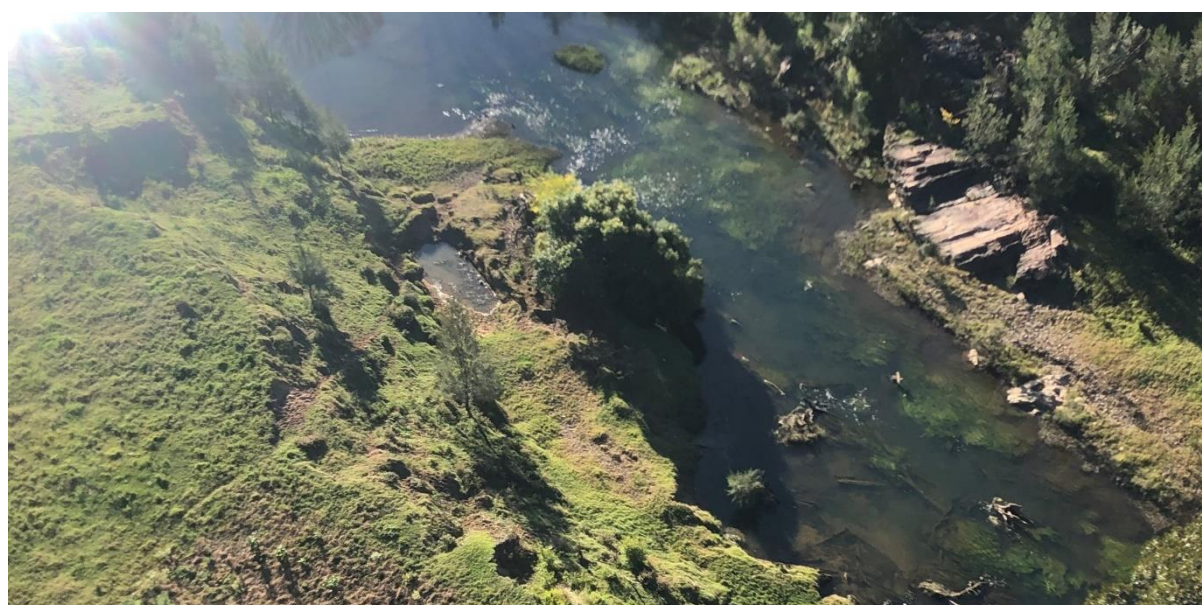
Figure 10: *Bedrock exposure at the spurred valley margins within the Mary River*

The streambed generally consists of sand and gravel deposits while the banks consist of predominately fine sands, silts and clays. The channel forms a series of shallow pools broken by riffles attached to sand and gravel points and bank attached bars and localised instream wood. In-channel bedrock exposures occur where the channel abuts the valley margins (Figure 10).

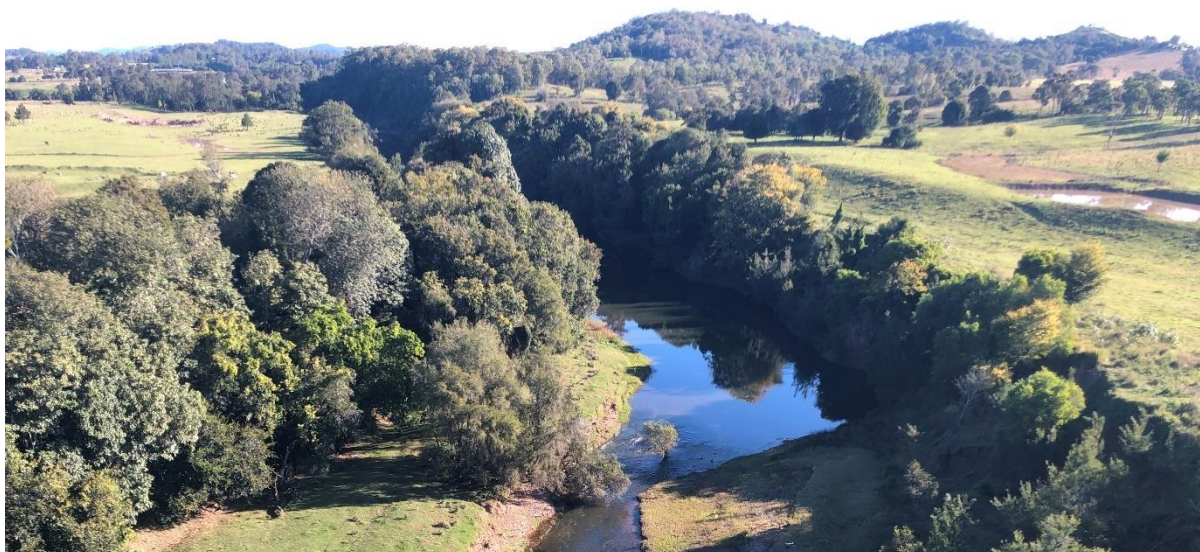
Figure 11: A section of improved riparian longitudinal connectivity in the upper section of the Mary River case study area

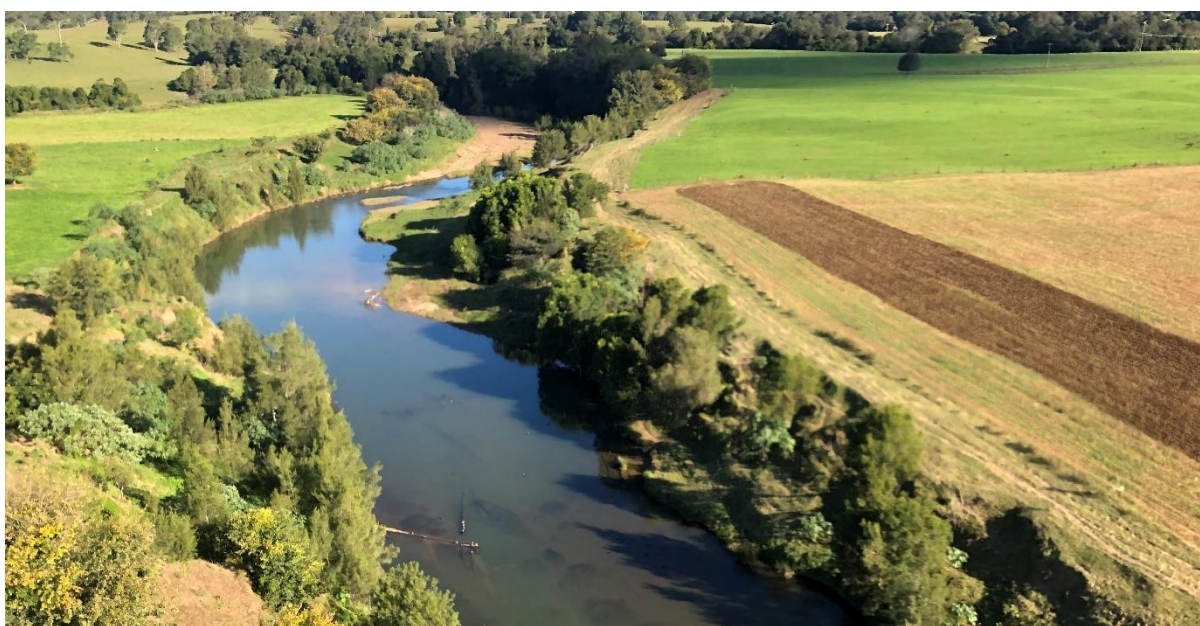
Figure 12: Establishing riparian vegetation is typically protected where bank slope limits cattle access

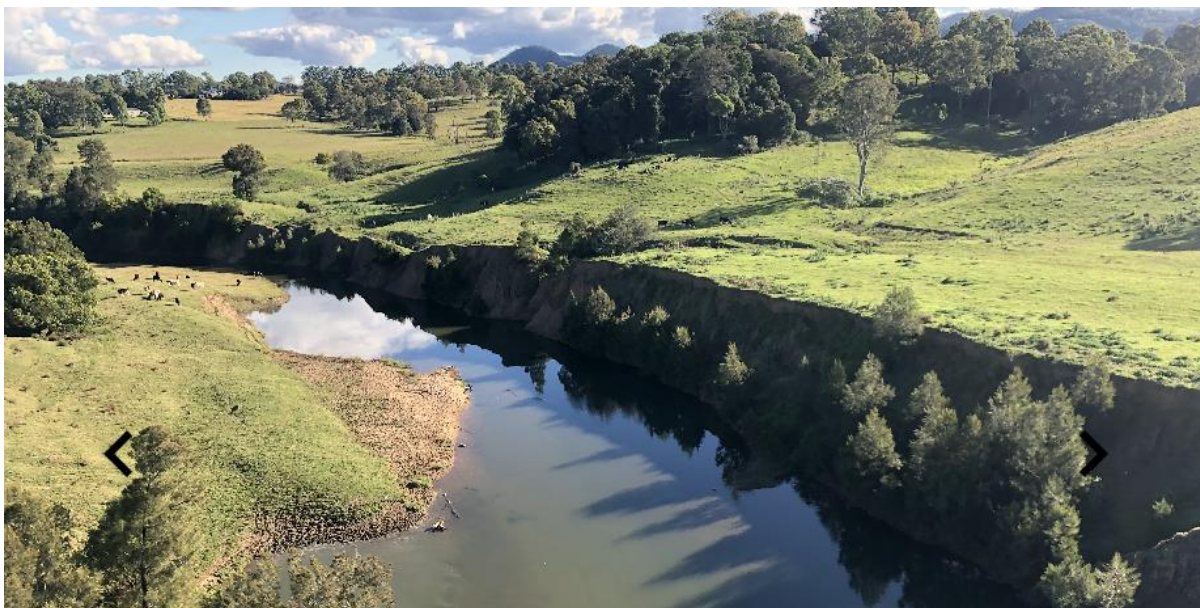
Figure 13: A section of the Mary River downstream of Traveston Crossing Road where there is regeneration along the lower bank on one side and unrestricted stock access on the opposite bank

Riparian longitudinal connectivity diminishes in extent towards Gympie. Recent riparian vegetation establishment is predominantly occurring along bank toes where steep bank profiles limit stock access. Where cattle access is facilitated by gentler slopes, riparian vegetation coverage is significantly less, featuring predominantly casuarina regrowth as opposed to the greater species diversity observed in protected areas (Figure 13). Overall, bank condition is severely degraded, with steep, exposed and unstable bank slopes particularly on poorly vegetated inset floodplain and bench units.

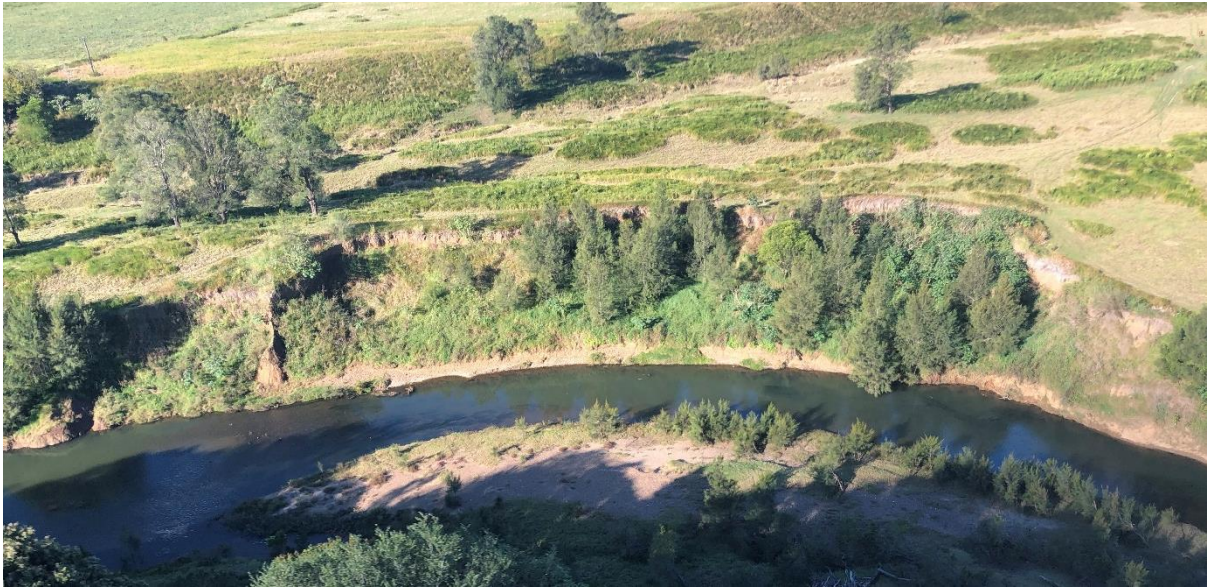
Figure 15: Meander development within an inset floodplain near Ashton Road within the Mary River case study area

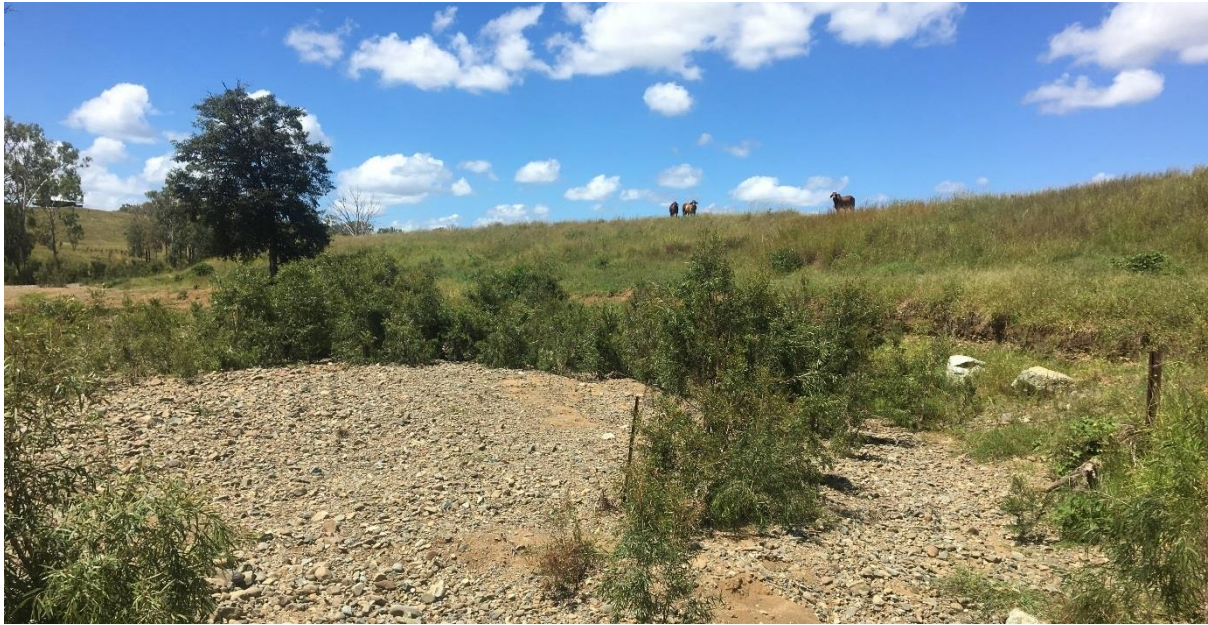
Figure 31: An example of abundant sandy/gravelly bed material, poor riparian vegetation and cattle impacts within Six Mile Creek which is in the upper portion of the Raglan Creek case study area

Six Mile Creek and the upper reaches of Raglan Creek flow through dispersive sodosol soils. The bed material consists of sands, gravels and cobbles, with occasional bedrock outcrops (Figure 31). Many stream banks within this region have vertical, steep or irregular morphology with exposed soils indicating lateral adjustment. Bedrock outcrops may be limiting large scale vertical and lateral adjustment. Riparian vegetation extent and condition is typically poor and is significantly impacted by cattle grazing (Figure 32 and Figure 33).

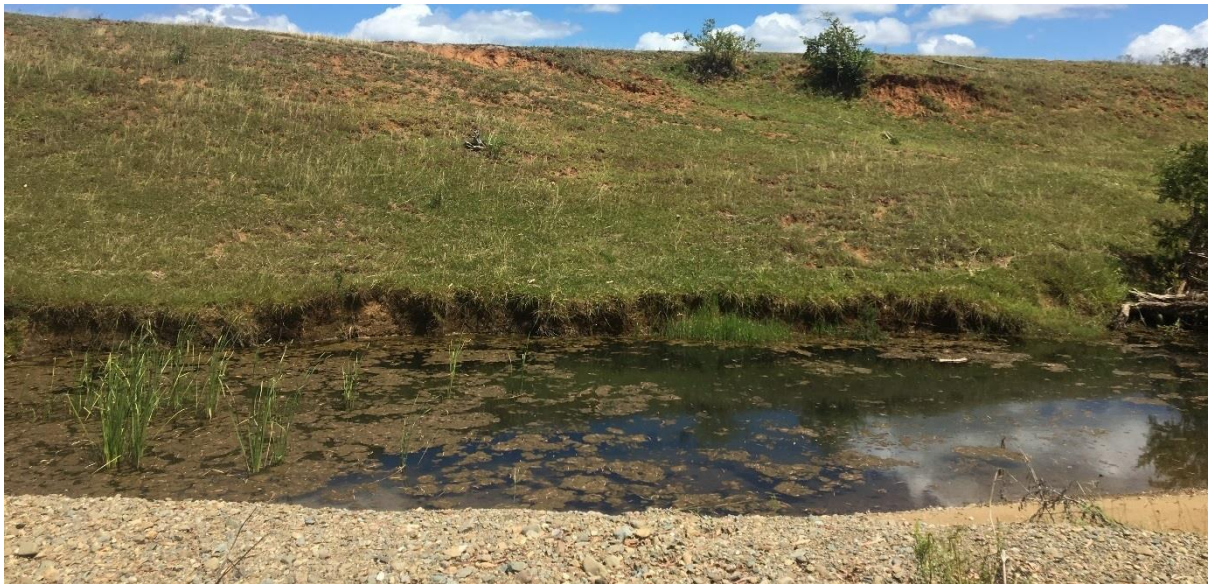
Figure 32: Limited riparian vegetation, stock impacts and stream bank instabilities in the lower reaches of Six Mile Creek within the Raglan Creek case study area

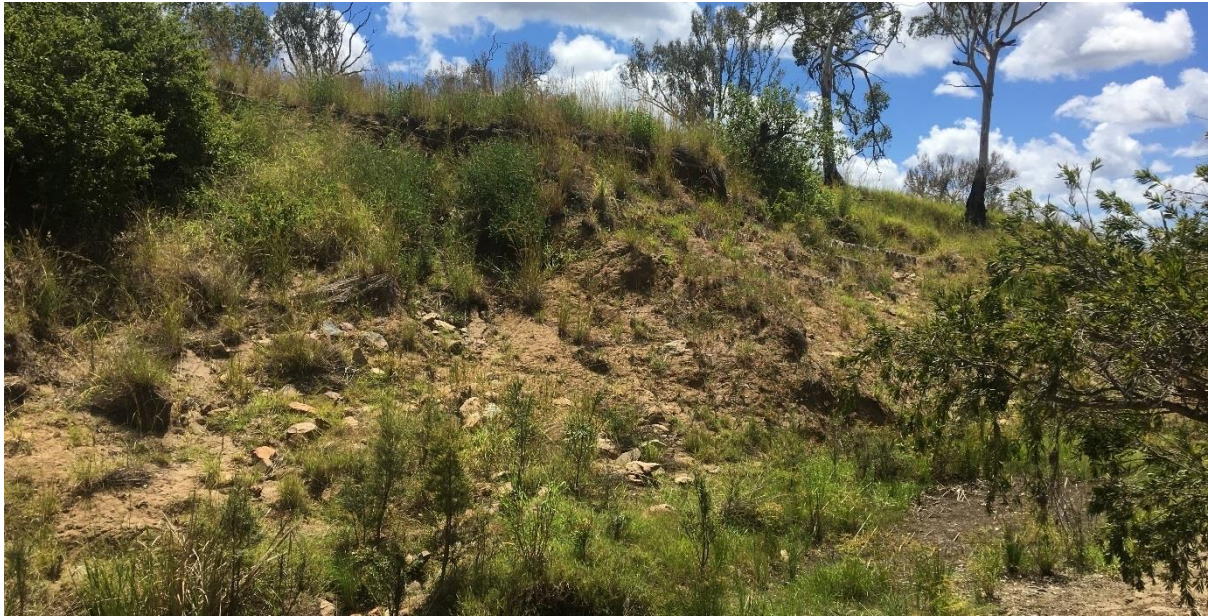
Figure 33: *An example of a steep and eroding bank in Raglan Creek*

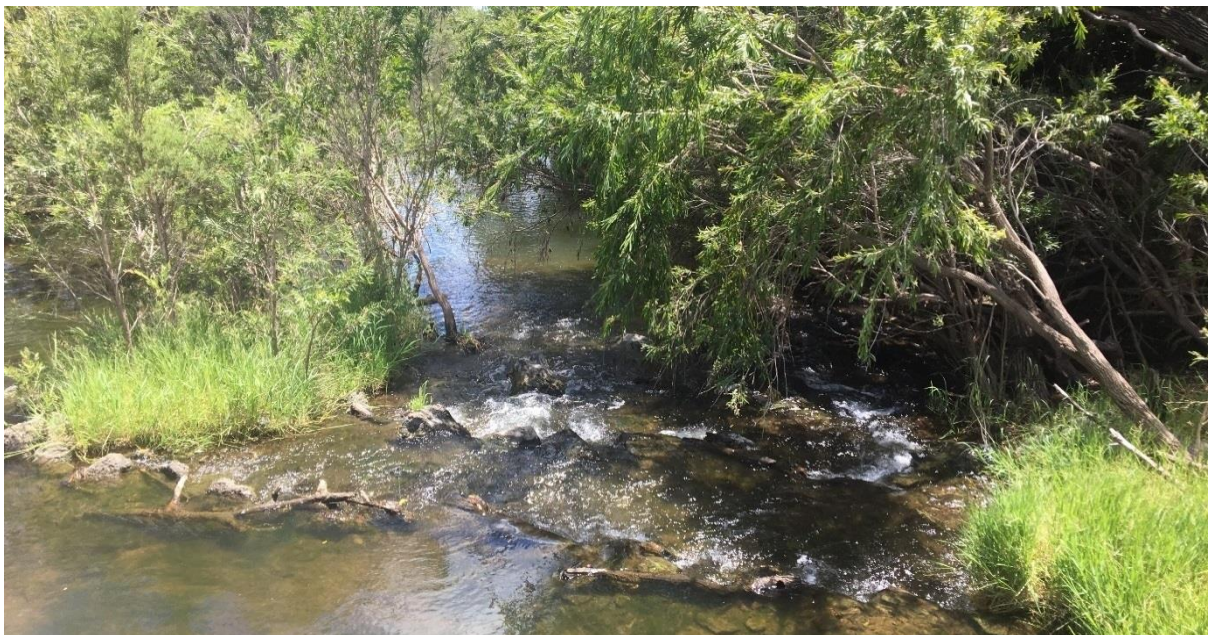
Figure 34: *An example of a stable section of the mid-reaches Raglan Creek with good riparian vegetation extent and instream diversity*

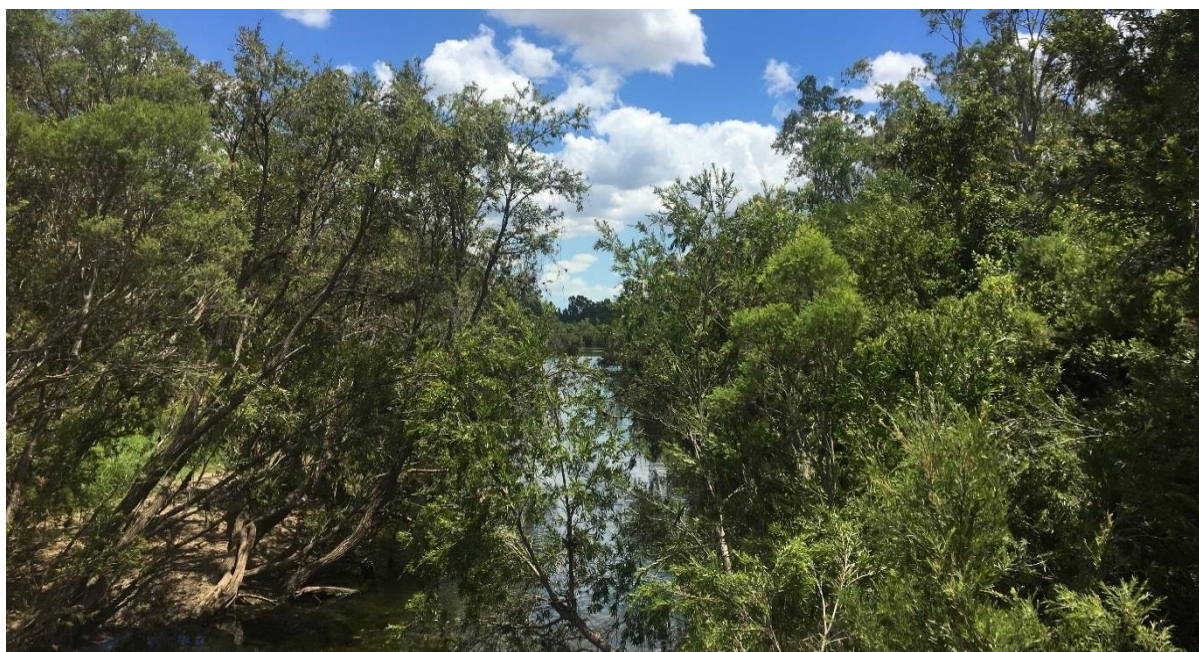
Figure 35: An example of good vegetation in the mid-reaches of Raglan Creek

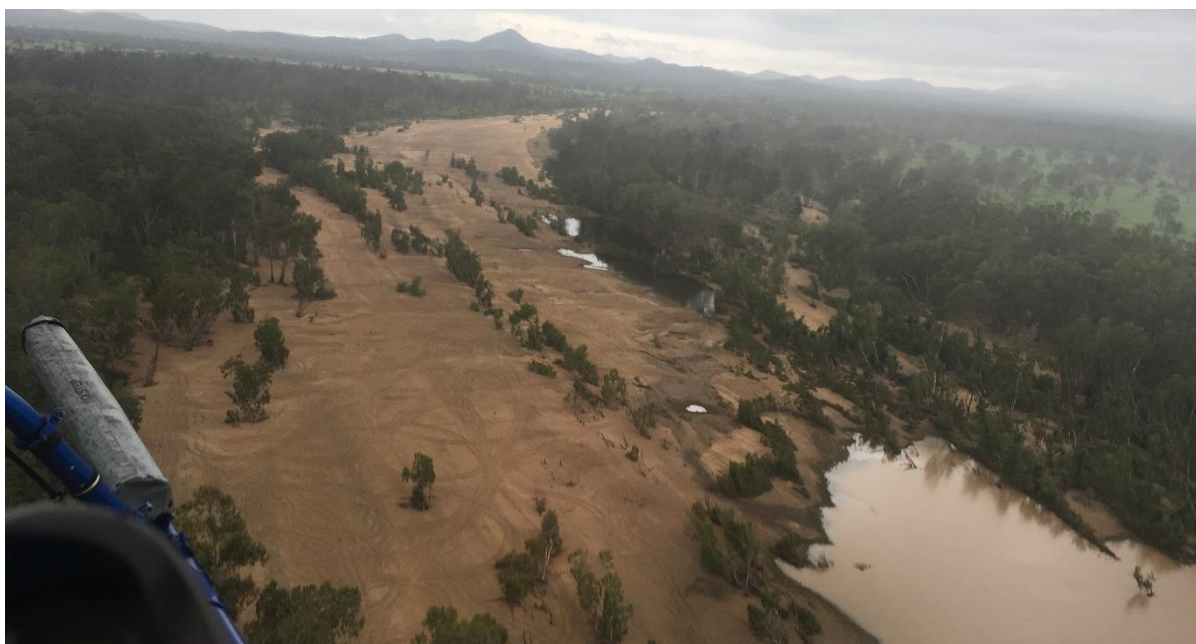
Figure 47: A wide in-channel bar within the Fitzroy River case study area

- wide inset bars, which sit approximately 2 to 5 m above the channel bed (see cross-section 3 in Figure 46, and Figure 47), and
- inset alluvial units including benches, which sit approximately 5 to 10 m above the channel bed (see cross-section 3 in Figure 46).

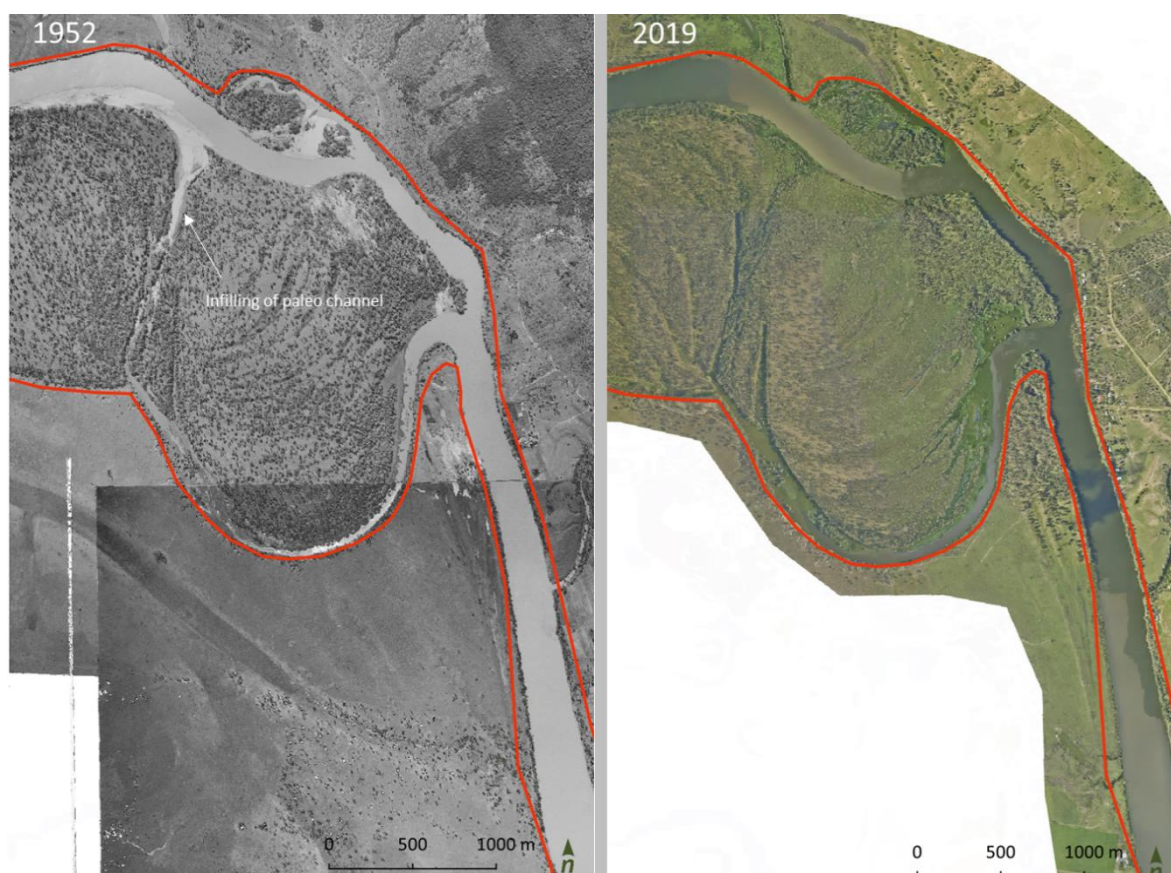
Figure 49: Comparison of historical aerial imagery within an active zone within the Fitzroy River case study area showing the shutdown of a previous water course

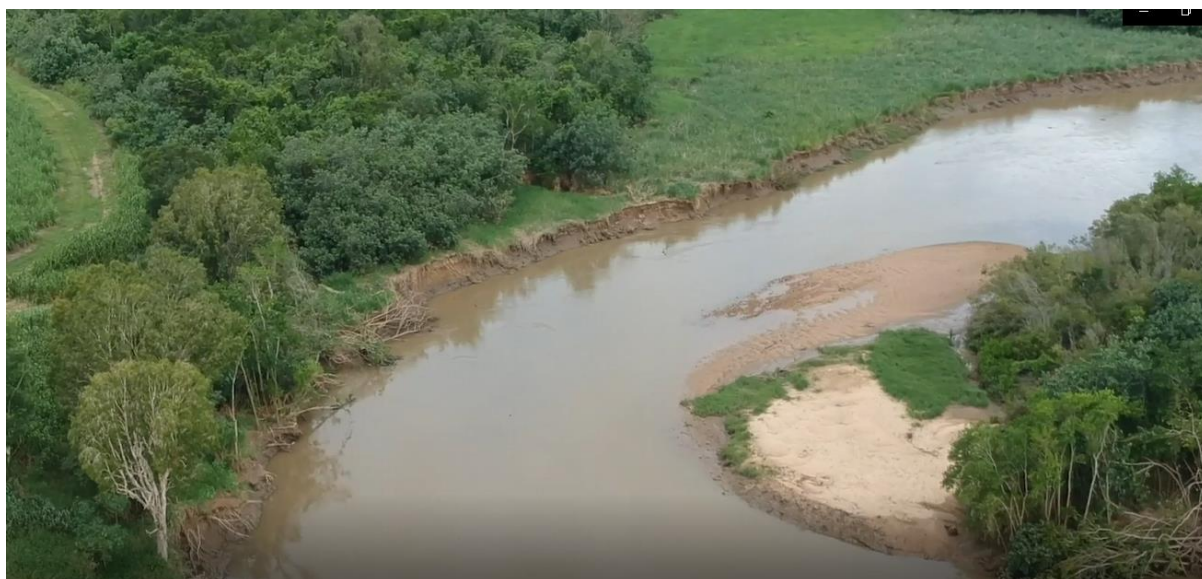
Figure 63: *The downstream section of Murray Creek case study area within the estuary where the banks consist of estuarine muds and there are sandy instream deposits*

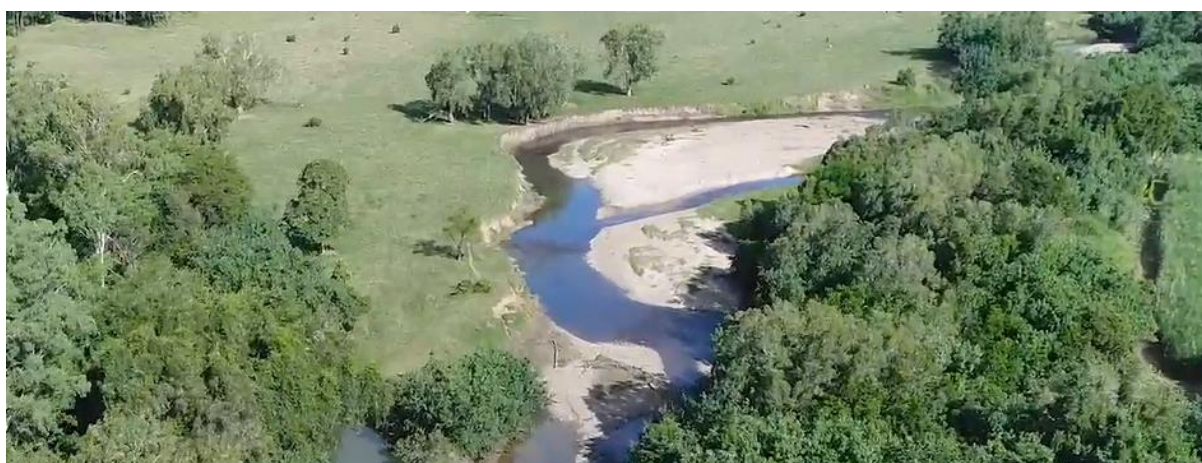
Figure 64: *Section of Murray Creek downstream of the Bruce Highway*

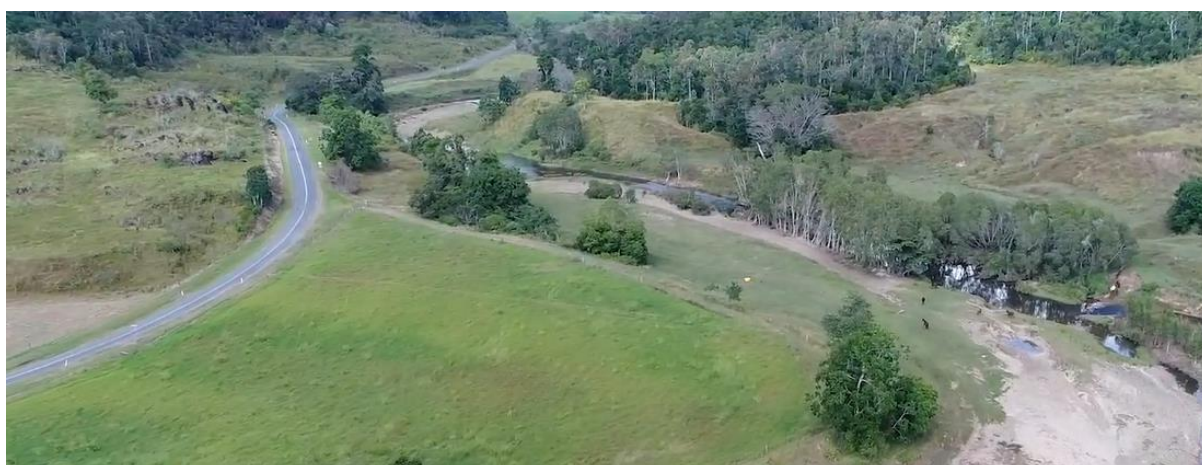
Figure 65: *Murray Creek through the bedrock-controlled section upstream of the Bruce Highway*

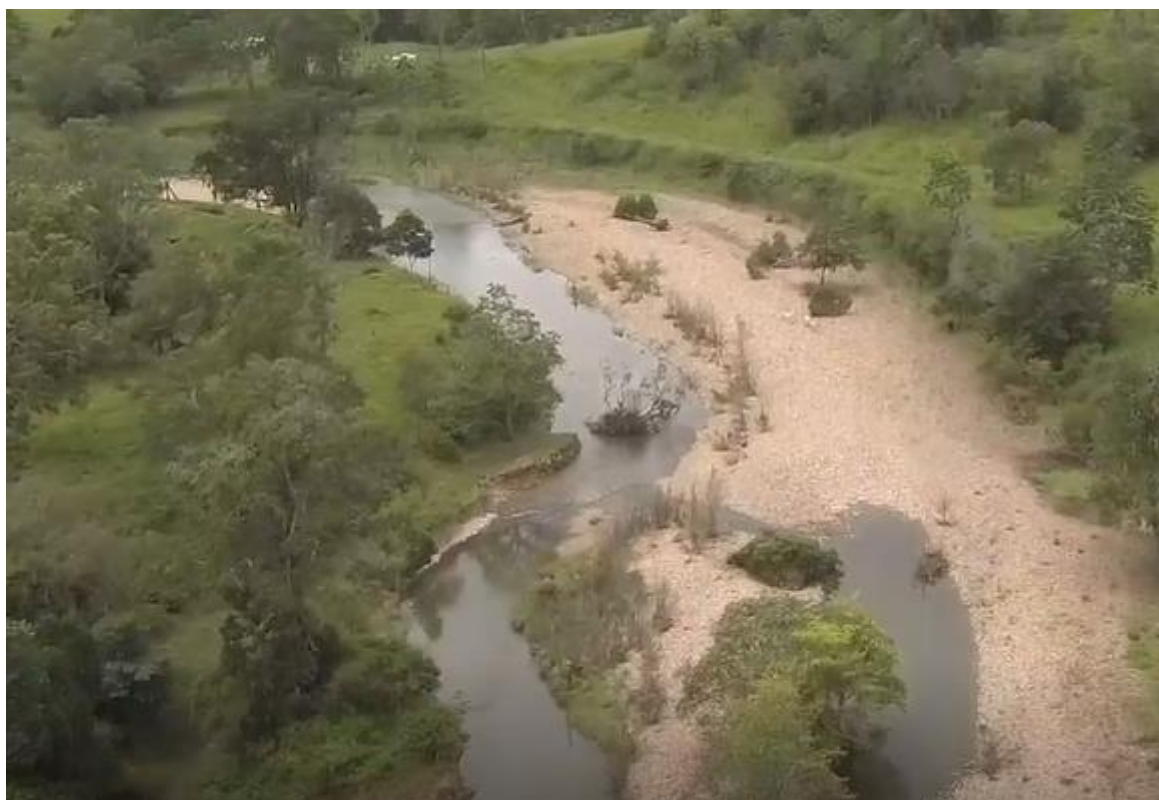
Figure 66: Bank attached gravel bar and associated riffles within Murray Creek

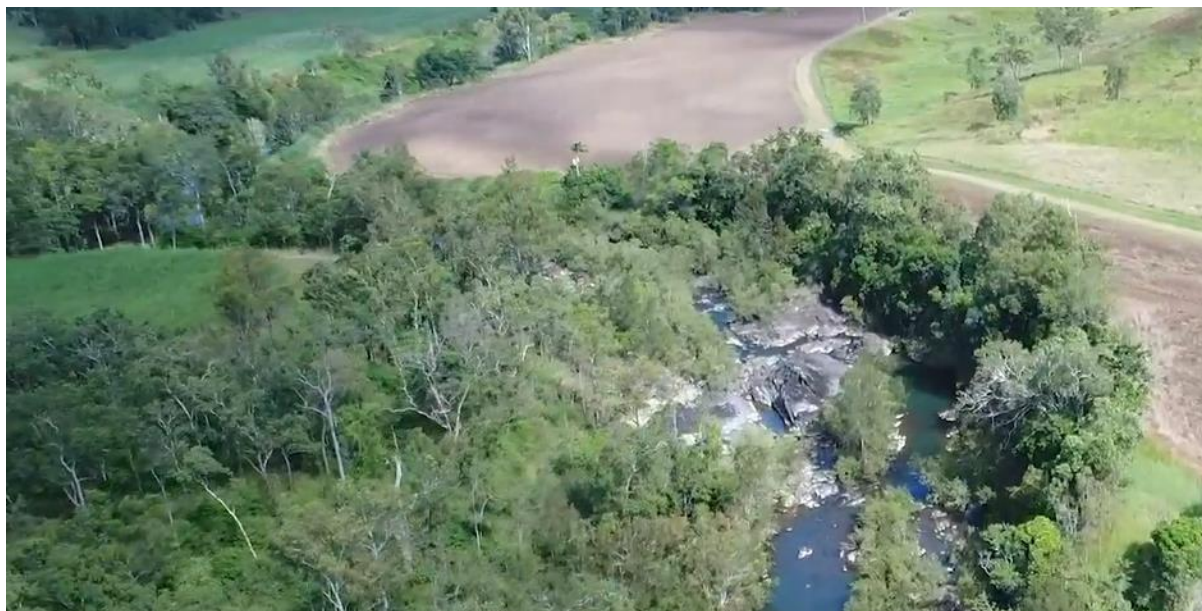
Figure 67: Bedrock control within Murray Creek adjacent to the forested hillslopes

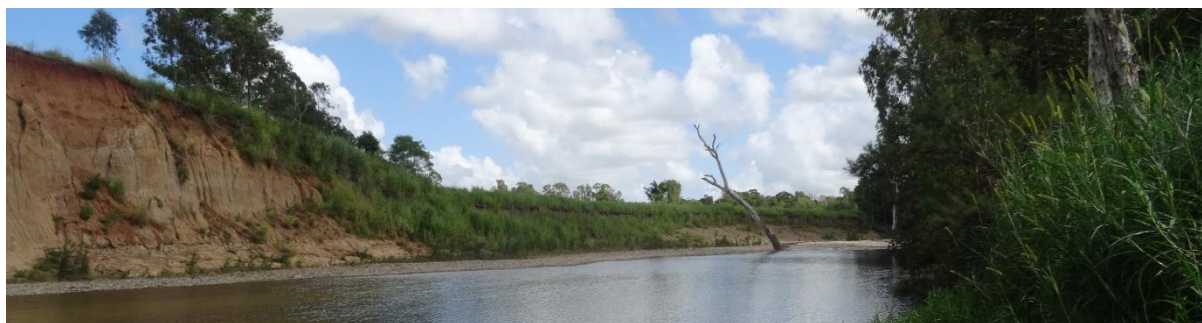
Figure 77: Looking across at the left bank immediately upstream of the Boundary Creek confluence – terrace to the left of the image and inset floodplain to the right

- Fill terrace units which sit 12-15 m above the channel bed, comprised of a red sandy clay (Figure 77).
- Inset floodplain and bench units which sit 3-6 m above the channel bed, comprised of silts, sands, gravels and cobbles (Figure 78).

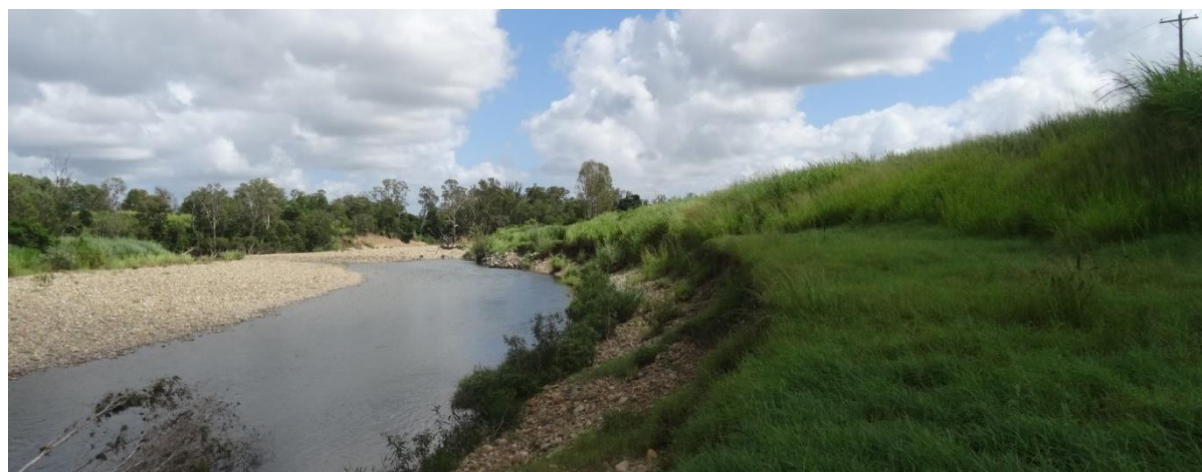
Figure 78: Looking downstream along the right bank located 1.5 km upstream of the Boundary Creek confluence. Site is subject to meander migration

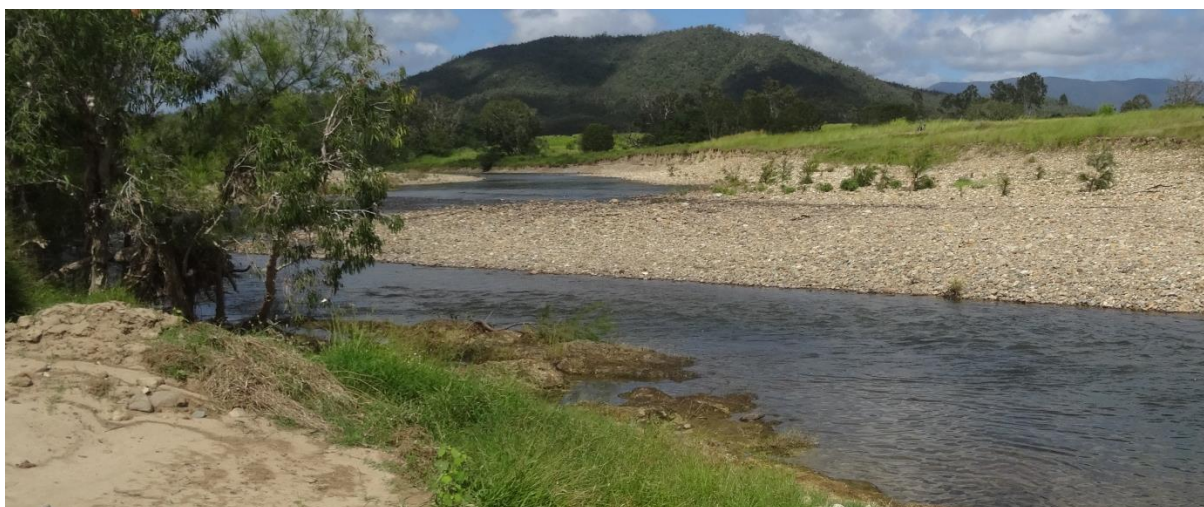
Figure 82: Looking across at the right bank upstream of the Boundary Creek confluence where there are abundant instream gravels

Throughout the case study area there is a low sinuosity gravel-to-cobble bed channel with some isolated bedrock control. Within the channel are extensive bars which form riffles through the system (Figure 82). Downstream of Dingo Creek confluence as the channel emerges from the confinement there is widespread channel aggradation. The aggradation predominately consists of gravels and cobbles. The O'Connell River transitions to predominantly sandy bed system closer to its mouth.

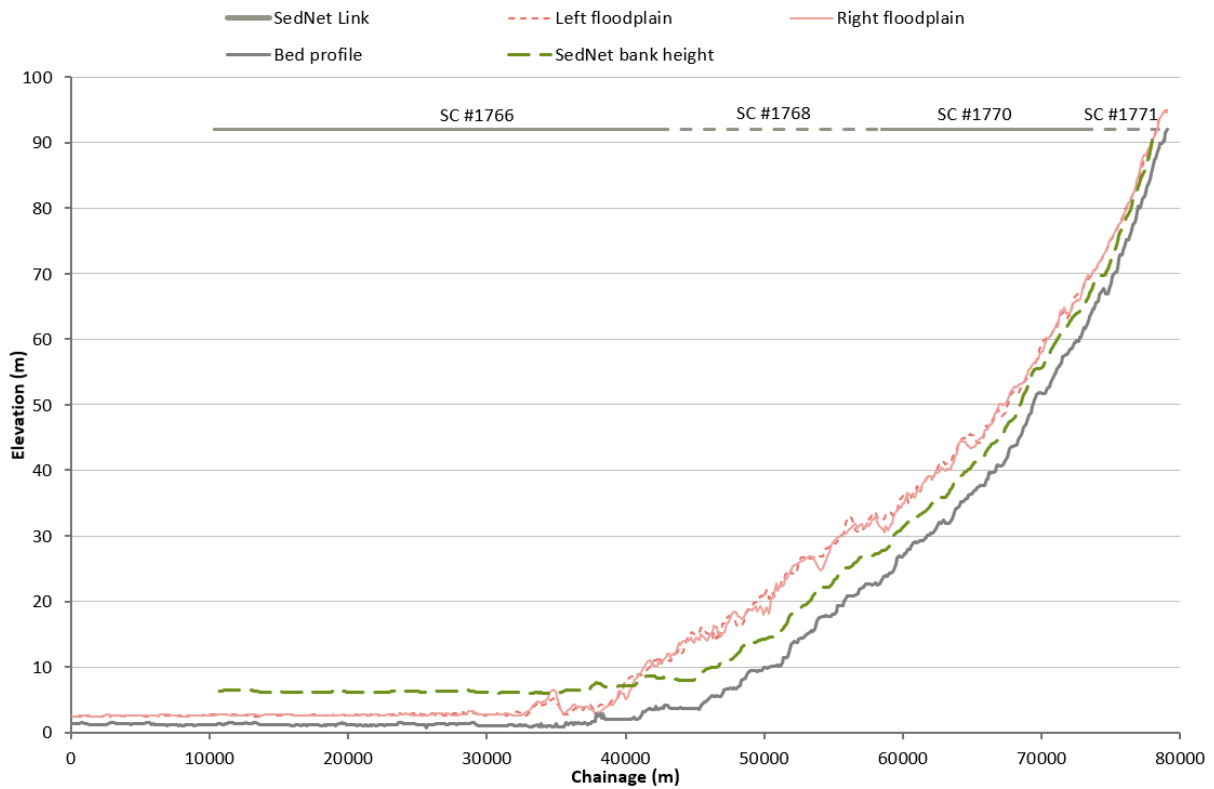
Figure 102: *Modelled link bank height and LiDAR derived bank height within the Raglan Creek case study area*

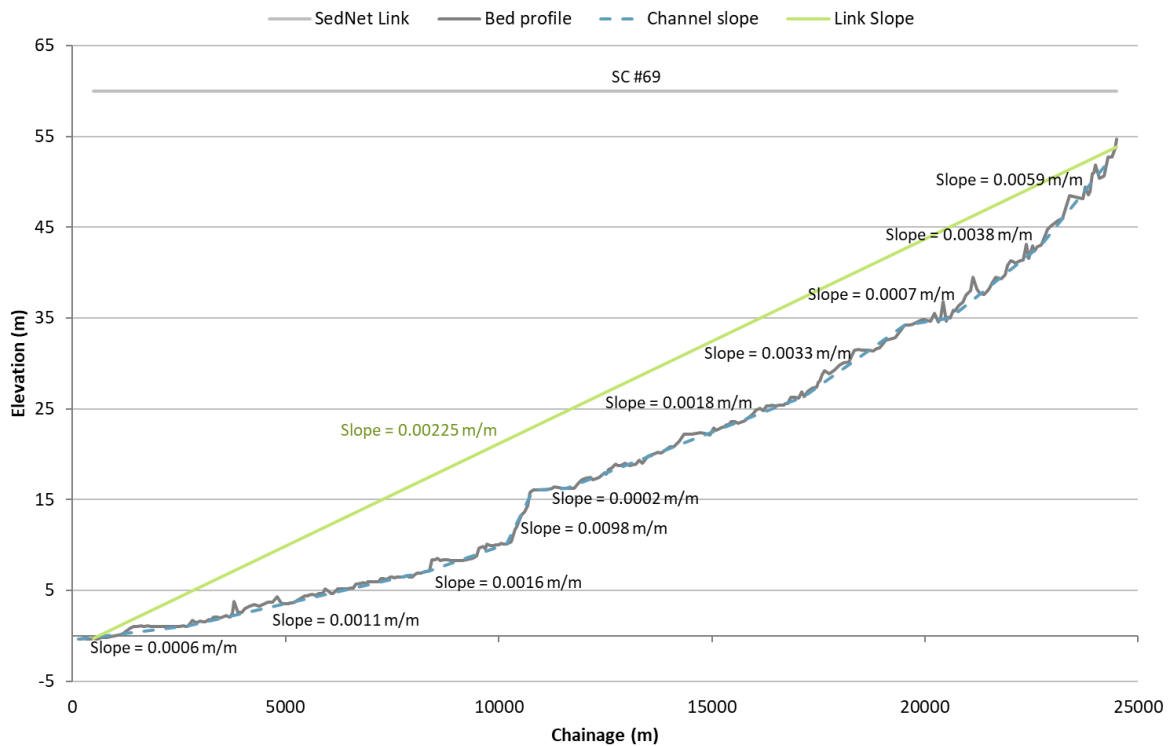
Figure 112: *Modelled link bed slope and LiDAR derived bed slope within the Murray Creek case study area*
